Microstructural Examination of Ni-ion Irradiated Fe-Ni-Cr Alloys Followed to Micro-zone Deformation

M. Ando, Y. Katoh, H. Tanigawa*, A. Kohyama and Y. Kohno**

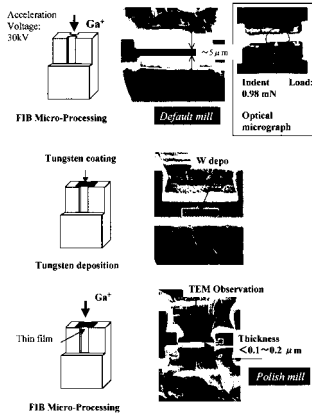
Fig.1: A schematic illustration of the procedure of micro-processing developed in this study.

Figure 1 illustrates a representing schematic procedure of micro-processing by means of the FIB. At first, the specimens were irradiated with 4 MeV Ni^{3+} ions and then micro-indented. These indents couldn't be observed by secondary electron or secondary ion images produced by the FIB system. However, they could be clearly observed by an optical microscopy. Secondly, following the initial specimen thickness reduction to about 5 μm by means of a coarse mode FIB-processing, the irradiated and indented surfaces were protected by physically depositing tungsten as thick as typically a few hundred nanometers. Finally, the thickness of thin films were further reduced to approximately 0.1 μm for the TEM examination. Figure 2 shows the typical bright field TEM image of the thin film right after the FIB processing. As noticeable in the micrograph, the FIB processing introduced very fine dot-like defects in the specimens. These defects are not precisely characterized but supposed to be mostly small dislocation loops of the interstitial type produced by the Ga ion bombardments. These defects could totally be removed by an electrolytic polishing for a very short time. These efforts successfully enabled a TEM examination of both irradiation- and indentation-induced microstructural defects.

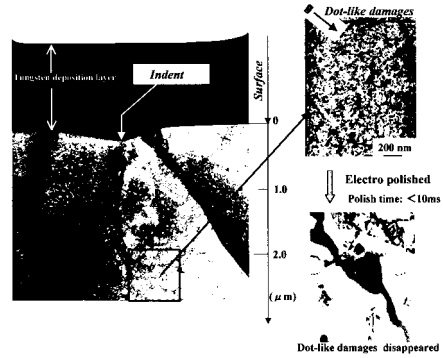
Fig.2: Transmission electron micrograph of the FIB-processed thin film before the electrolytic polishing.

- The FIB processing introduced very fine dot-like defects in the specimens. The defects could easily be removed by electrolytic polishing. Tungsten deposition prior to the FIB processing was essential to protect the original irradiated surface.
- Both irradiation- and indentation-induced defects were clearly observed by TEM. The distribution of damage microstructures due to the ion-irradiation was in good agreement with the TRIM calculation.

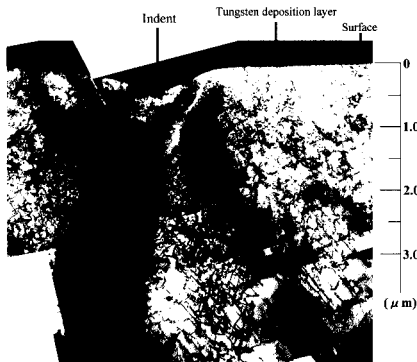
Fig.3: Bright field TEM image of the region beneath the indent in the unirradiated specimen.

Figure 3 shows the region right beneath the indentation in the unirradiated specimen. In this region, high density dislocations correspond to plastic deformation were observed. The radius of high dislocation density region was about 2.5 μm . The depth of indent after the indenter removal was about 330 nm, whereas the maximum indenter displacement below the original surface during the indentation test was about 345 nm. The shape of the deformed volume was rather anisotropic; the deformation reached as far as about 3.0 mm from the indent top in some directions though it stopped at less than 1.5 mm in other directions. This observation suggests the limited applicability of simple deformation models for the micro-indentation [8]. The deformation was also frequently observed to be terminated at the grain boundaries, although such function of the grain boundaries will substantially be influenced by their characteristics.

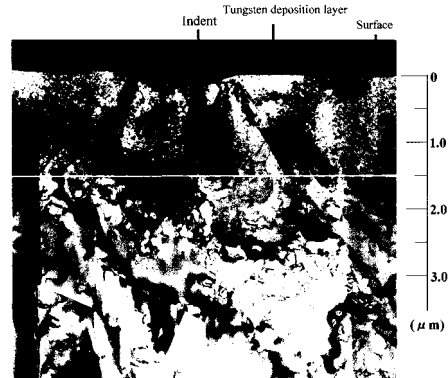
Fig.4: Bright field TEM image of the region beneath the indent in the irradiated specimen.

The microstructure around the indent in the irradiated specimen is presented in figure 4. In the region free from the indentation-induced deformation, the distribution of damage

microstructures due to the ion-irradiation was in good agreement with the damage distribution profile calculated by the TRIM code. In the case of irradiated specimen, the volume of indentation-induced high dislocation density region was significantly smaller than in the unirradiated specimen for the same indentation load, because of the increased plastic deformation resistance due to the irradiation-produced defects. The shape of the plastically deformed region seems like more hemispherical than that in the unirradiated specimen. This could be explained that the uniform distribution of the irradiation-produced high density small dislocation loops on four $\{111\}$ family planes in the face centered cubic lattice worked as an isotropic barrier against the motion of $a/2 \langle 110 \rangle$ dislocations. The observation of the significant reduction in the dislocation loop number density within the highly deformed region indicates the Frank loop sweeping mechanism [9,10] by the mobile dislocations.
